**Project Description:** CCTV Drainage Survey

**Project Number:** 2019-272

**Project Date:** 05/07/2019

**Project Standard:** MSCC5 Sewers & Drainage GB (SRM5 Scoring)

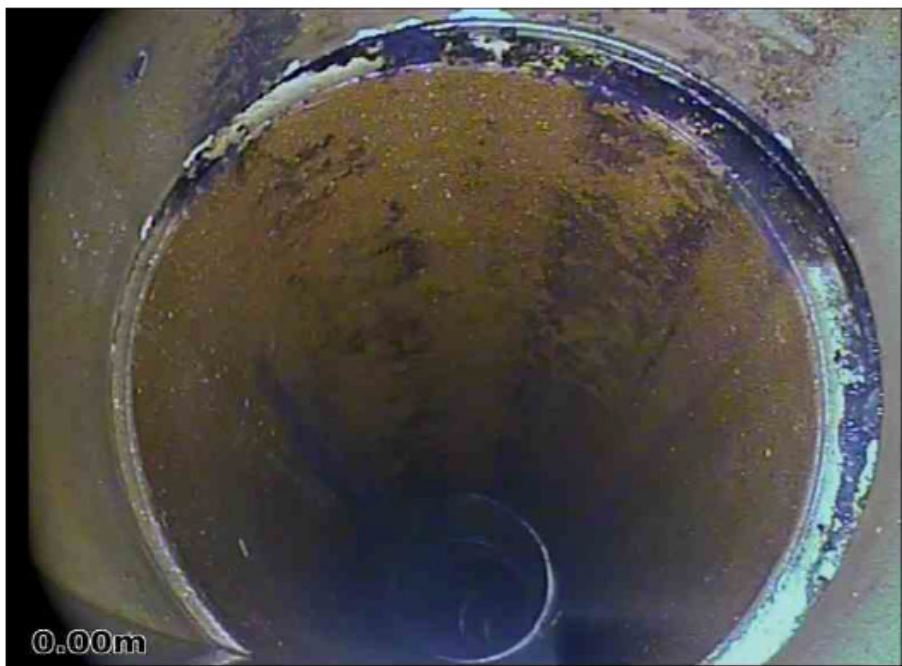
0.00	OJL	Open joint, large	1	0.00m // 00:00:02.87 //
	0.72	OJL	Open joint, large	1

, 00:00:02, 0.00 m  
Open joint, large

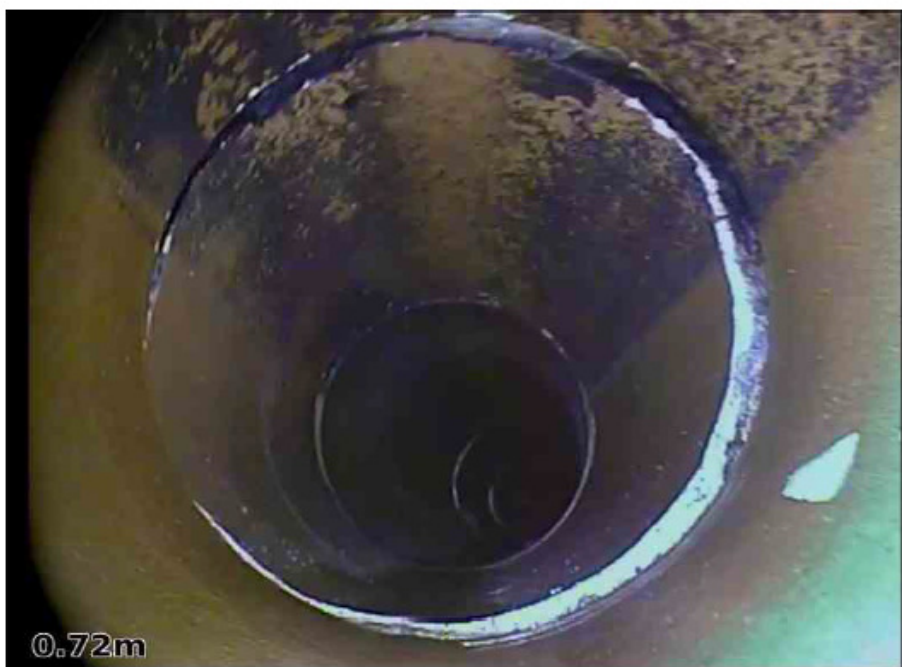
, 00:00:09, 0.72 m  
Open joint, large

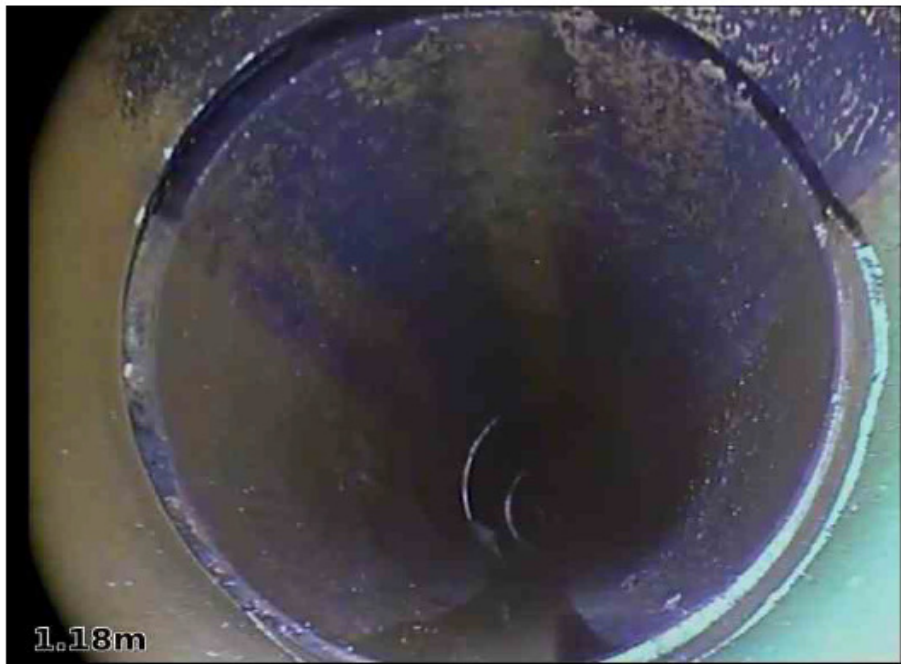
1.18	CCJ	Crack, circumferential at joint from 2 o'clock to 6 o'clock	2 / 2

, 00:00:12, 1.18 m  
Crack, circumferential at joint from 2 o'clock to 6 o'clock

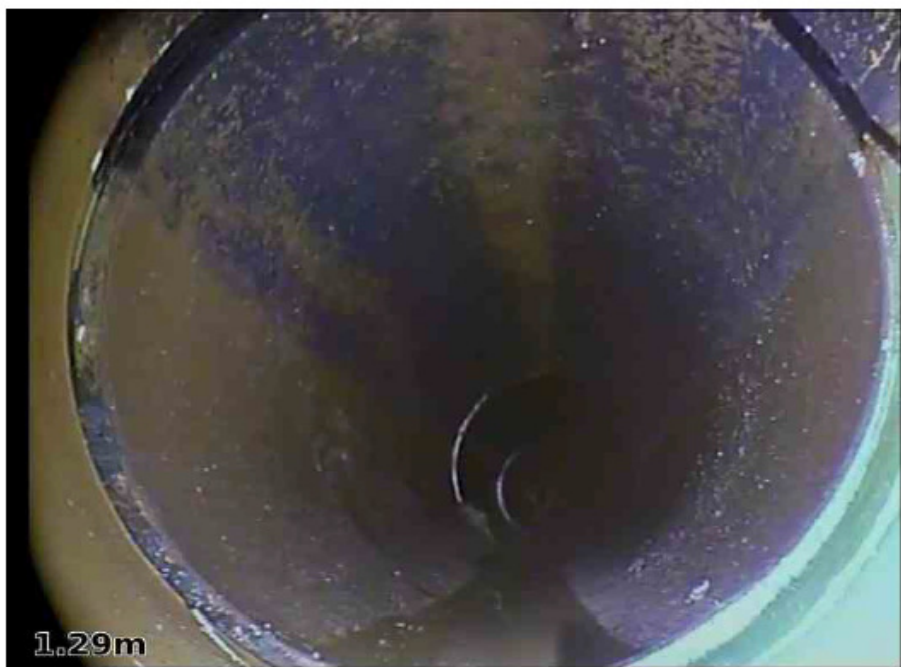
, 00:00:12, 1.22 m  
Open joint, medium

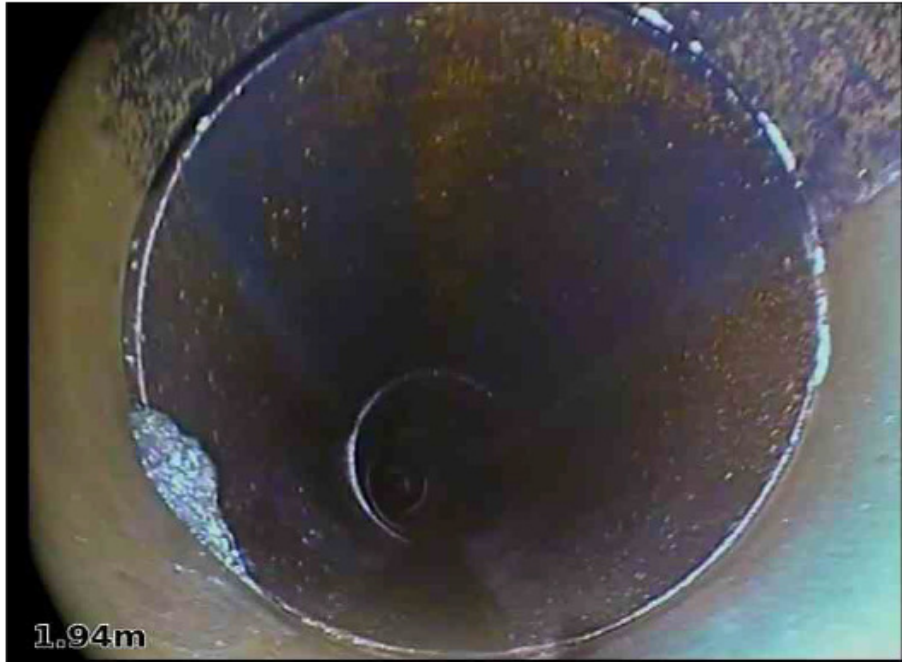
, 00:00:17, 1.94 m  
Open joint, medium

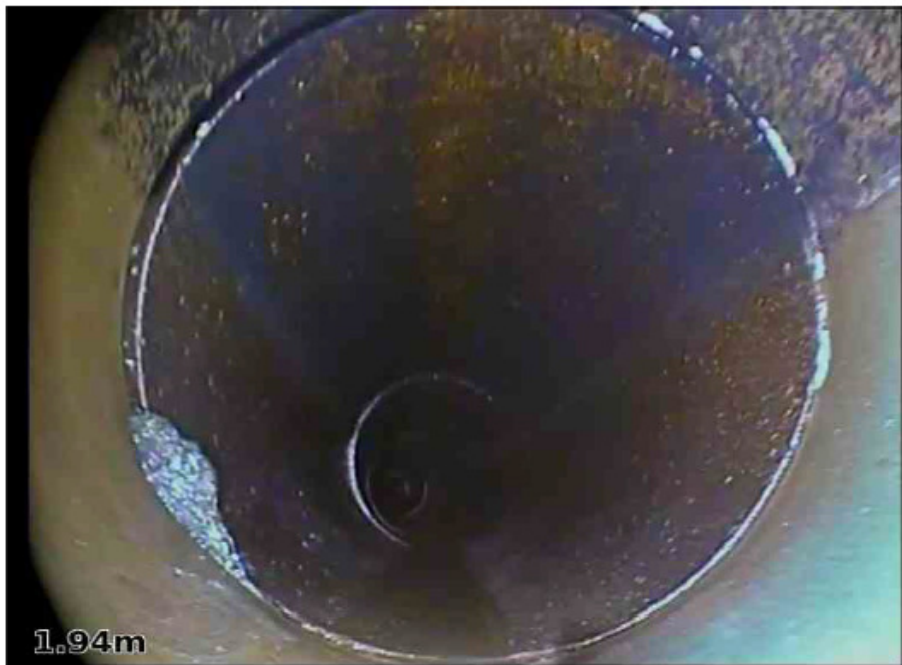
1.94	DECJ	Settled deposits, hard or compacted at joint, 5% cross-sectional area loss	3	1.18m // 00:00:12.18 //

, 00:00:17, 1.94 m  
Settled deposits, hard or compacted at joint, 5% cross-sectional area loss

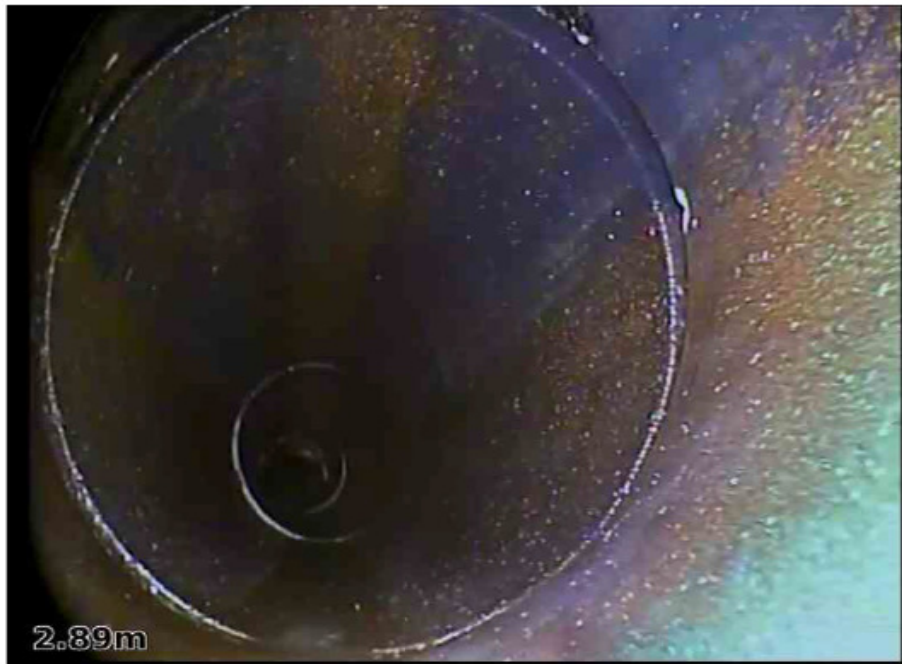
, 00:00:20, 2.81 m  
Open joint, medium

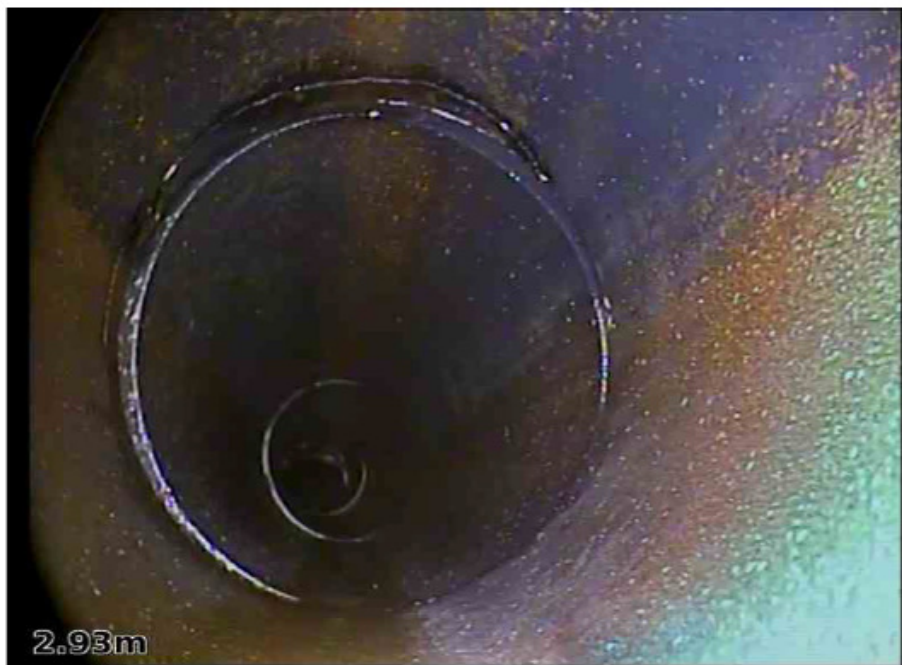
, 00:00:22, 2.93 m  
Crack, circumferential at joint from 9 o'clock to 1 o'clock

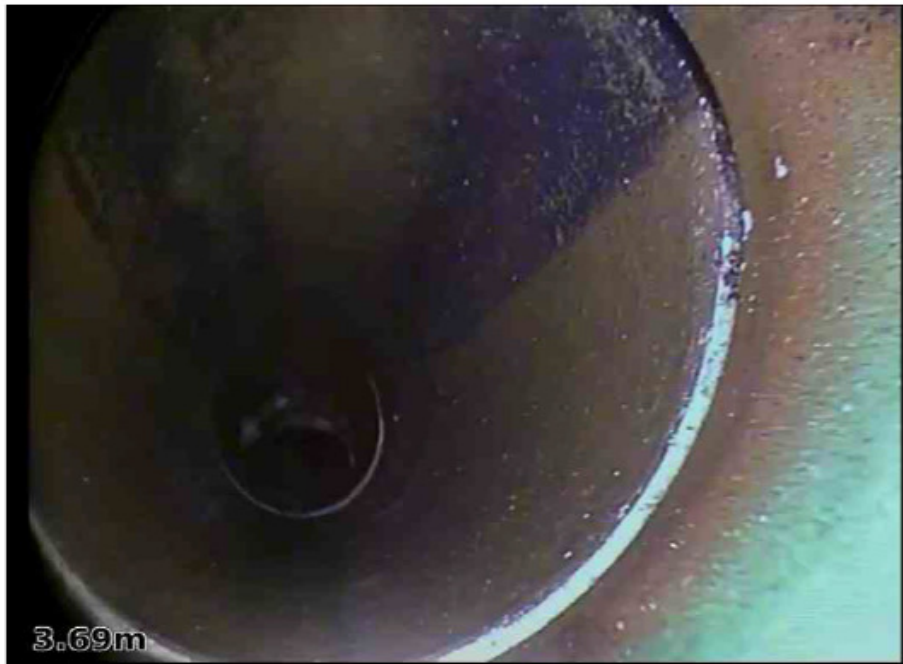
, 00:00:26, 3.69 m  
Open joint, medium

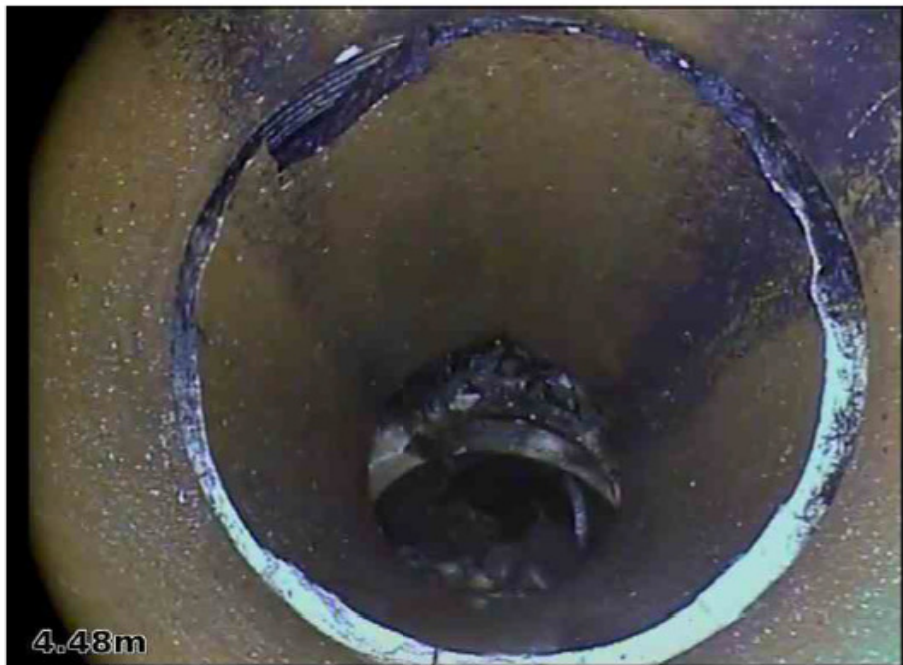
, 00:00:30, 4.48 m  
Open joint, large

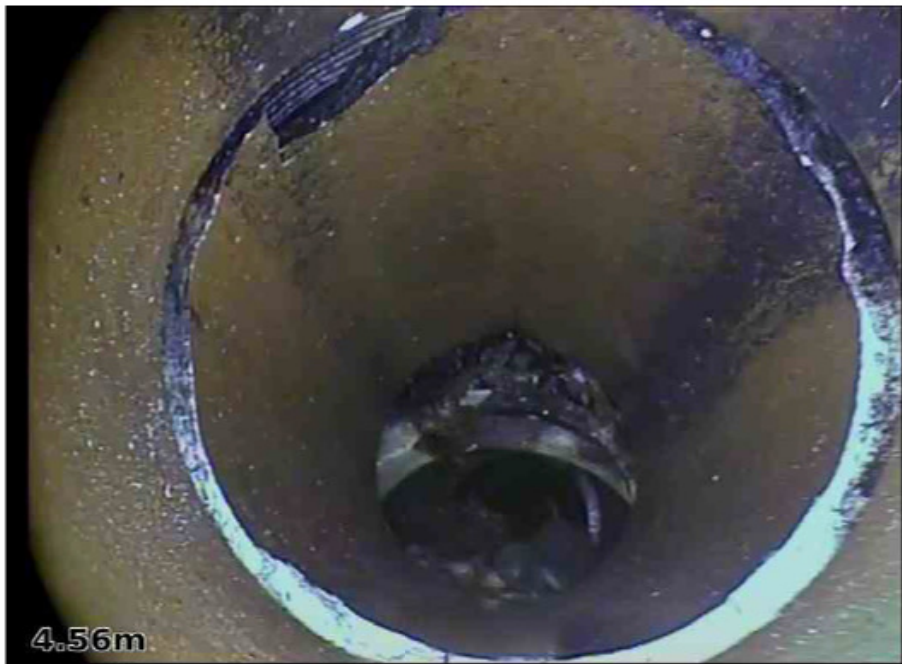
4.48	OJL	Open joint, large	1	1.22m // 00:00:12.50 //
	4.56	BJ	Broken pipe at joint from 10 o'clock to 11 o'clock	4

, 00:00:30, 4.56 m  
Broken pipe at joint from 10 o'clock to 11 o'clock

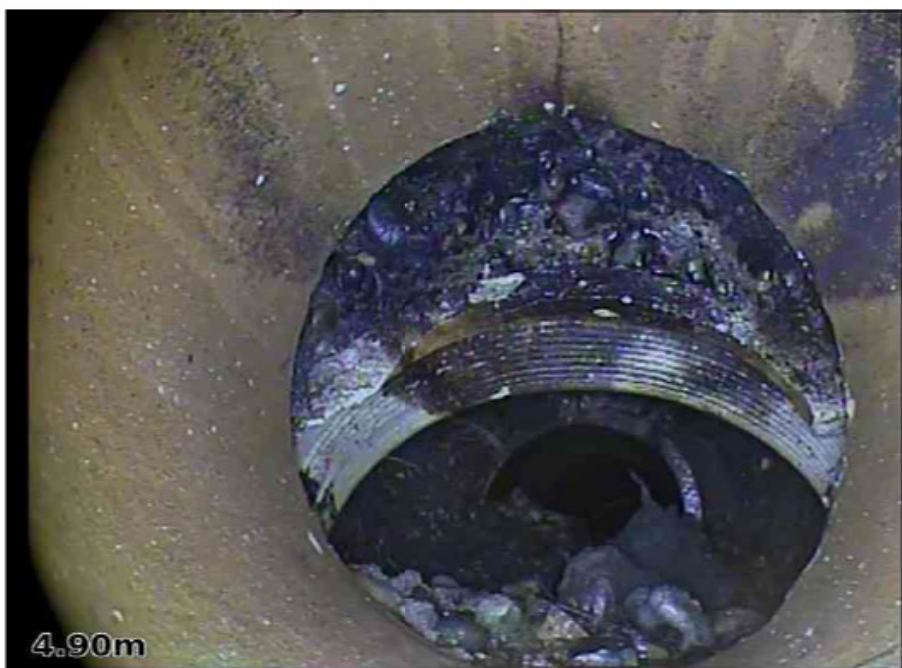
4.90	XP	Collapsed drain or sewer	5	1.94m // 00:00:17.00 //

, 00:00:38, 4.90 m  
Collapsed drain or sewer

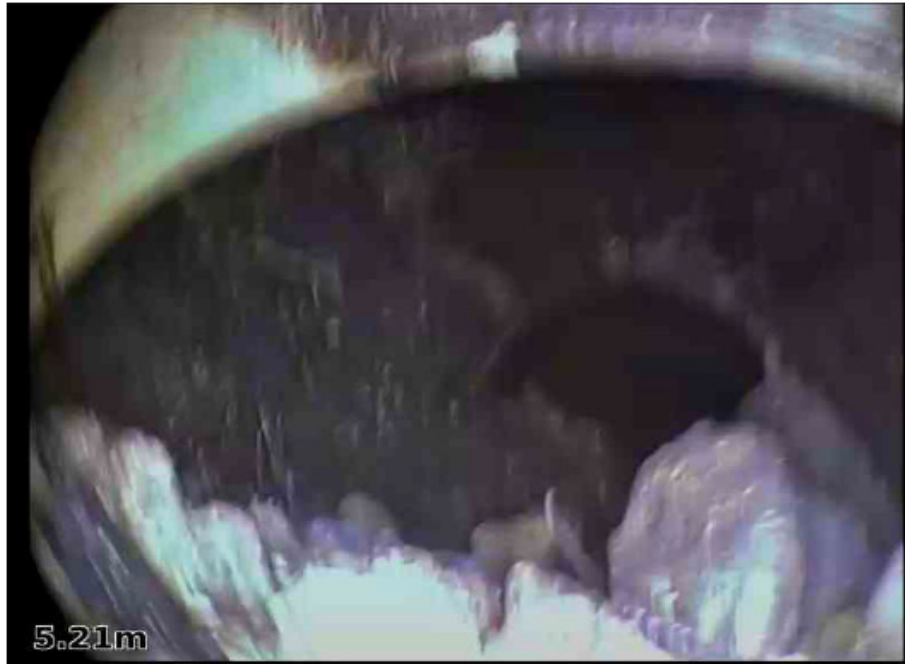
, 00:00:47, 5.21 m  
Survey abandoned, due to collapse

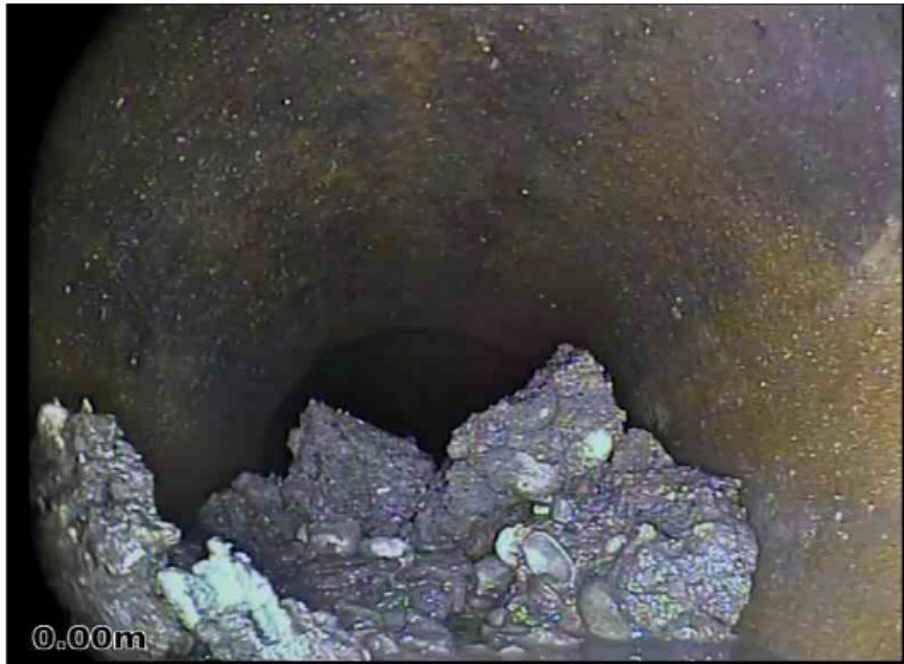
, 00:00:03, 0.00 m  
Settled deposits, coarse, 80% cross-sectional area loss

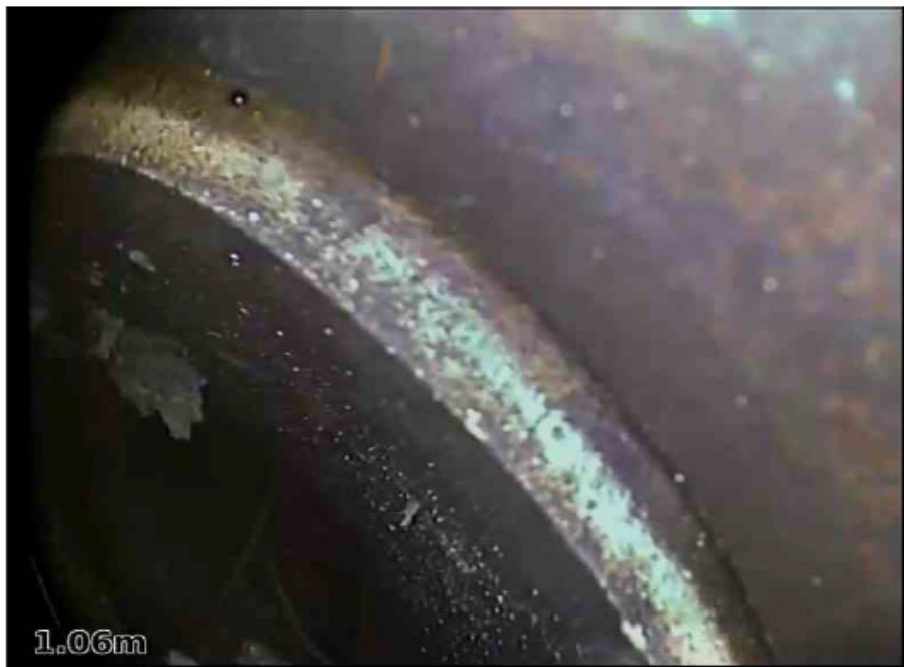
, 00:00:11, 1.06 m  
Open joint, medium

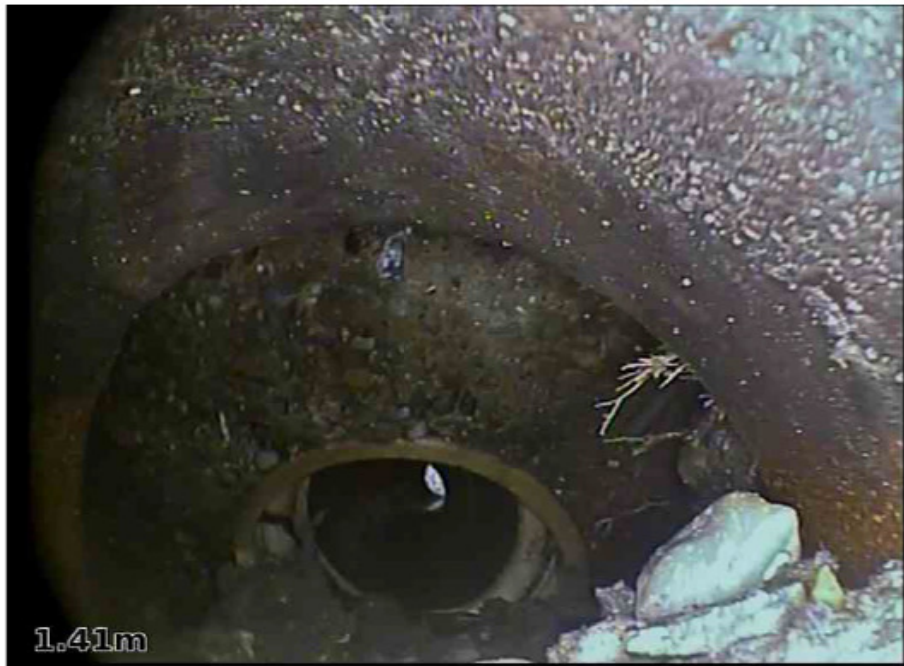
, 1.41 m  
Collapsed drain or sewer

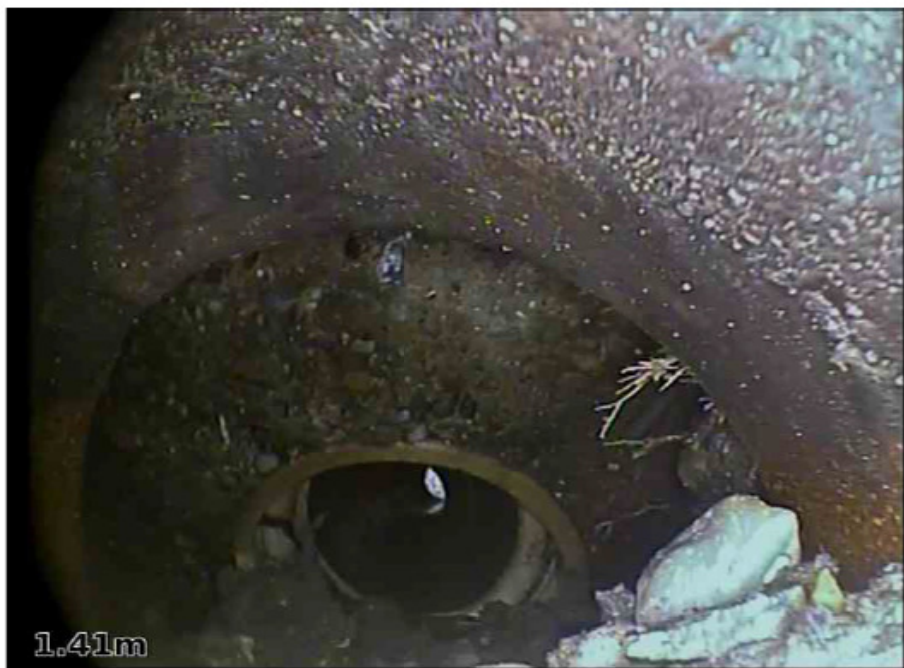
, 1.41 m  
Survey abandoned, Overlap complete
